Property Inspection Report

XXXXXX Place
XCXXXX, PA 190XX
Prepared for: Mr. & Mrs.XXXXXXX

Prepared by: Insight Home Inspections, Inc.
XXXXXXXXXX
Warminster, PA 18974
215-674-1808

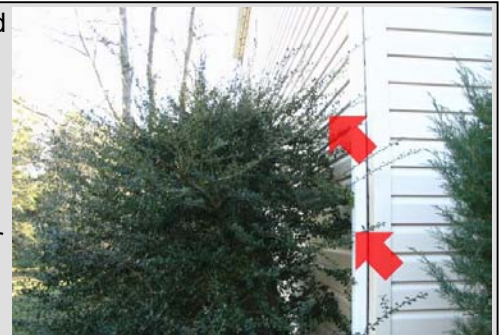
Maintained in most areas. Recommend trimming tree branches away from structure. Branches in contact with the house can damage the structure and allow easy access for wood destroying insects into the house. Large trees are noted on the property. Recommend contacting a qualified tree surgeon after you move into the property to provide assessment and recommendations regarding necessary maintenance needed for trees.

Keep branches trimmed away from structure

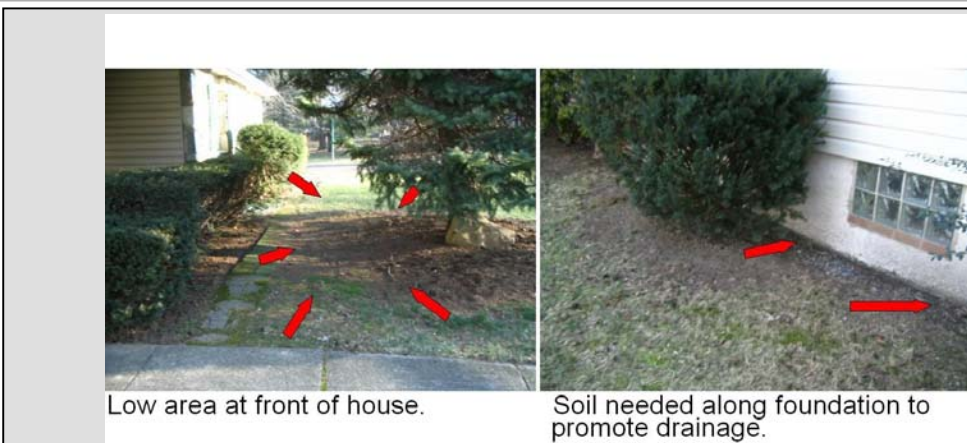
Low area at front of house.

Soil needed along foundation to promote drainage.

Gentle to moderate slope. Grade at foundation appears serviceable in most areas. Adjustment is recommended to grade in a few locations (front of house between tree and house and at rear of property along the foundation). Add soil in any areas of settlement or poorly sloped areas around foundation to promote drainage away from the foundation. It is a good practice to have at least 1/4 inch per foot sloping away for the first 10 feet if possible. A good fill soil is recommended that contains some clay. Avoid using permeable soil such as topsoil and sandy materials.

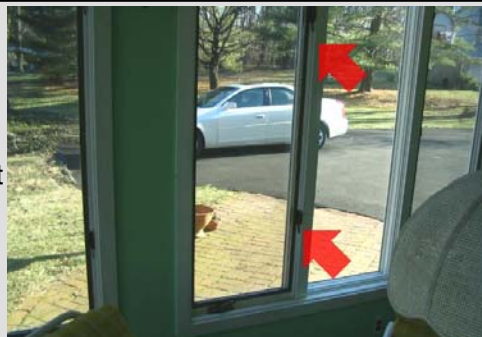
Appears serviceable. Concrete patio appears serviceable. Carpet restricts viewing of rear porch concrete floor. Overall condition appears serviceable. Asbestos type shingle siding in rear porch present. Note that some tiles that appear to be asbestos actually are cement tiles. We do not determine if the shingles actually contain asbestos. This type of shingle is not a health risk as long as they are not broken. Casement windows present. One of the casement windows along the driveway is difficult to lock. Adjustments/repair needed to hardware.

Window is difficult to latch

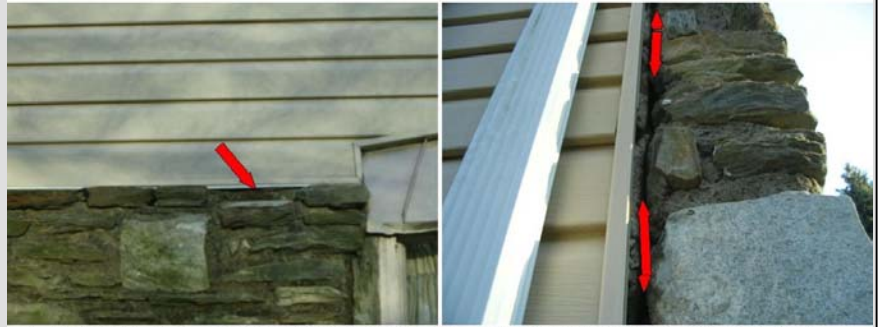
Repair missing stone at front of house. Sealant needed where vinyl siding meets stone.

Appears serviceable, Cracks noted are typical, Recommend sealing any cracks or openings to prevent water entry which can cause damage. Typically silicone type caulk is used for exterior sealing. Sealing is an ongoing part of exterior maintenance and should be performed as needed or every few years. Sealant and repair to one of the stones is recommended at front of house. Mortar is recommended along the side of the house where stone front meets the vinyl siding to prevent moisture entry.

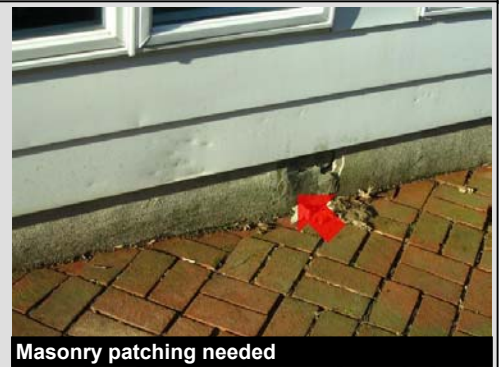
Masonry patching is needed at foundation area of the rear porch enclosure.

Masonry patching needed

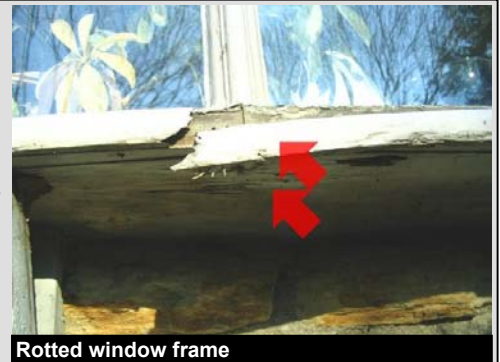
Appears serviceable, Keep in mind in the future to keep areas sealed where different materials meet. Any areas where water can enter during a heavy rain can cause structural damage if not maintained. Maintain building water tightness. Exterior trim and portions of window framing are rotted on the front of the house (living room window). Repairs or sealant recommended to damaged trim (left side of window) to prevent potential for moisture entry at side of window. Future upgrades to window may be needed.

Rotted window frame

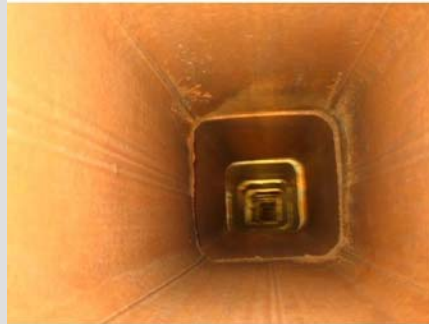
Inside of furnace liner.

Flue liners appear serviceable. Viewing of the flue liner is limited in scope to what is visual to the inspector. If further evaluation of flue liner is desired we recommend contacting chimney companies that are capable of running a camera through the chimney for a full evaluation. Chimney inspections are recommended annually to limit risks associated with a dirty chimney. Cleaning is recommended yearly to prevent creosote and soot deposits which are highly flammable and create a fire hazard.

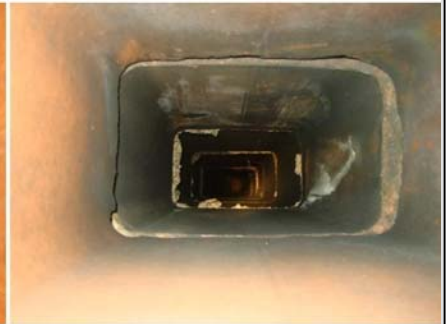
Inside of fireplace liner.

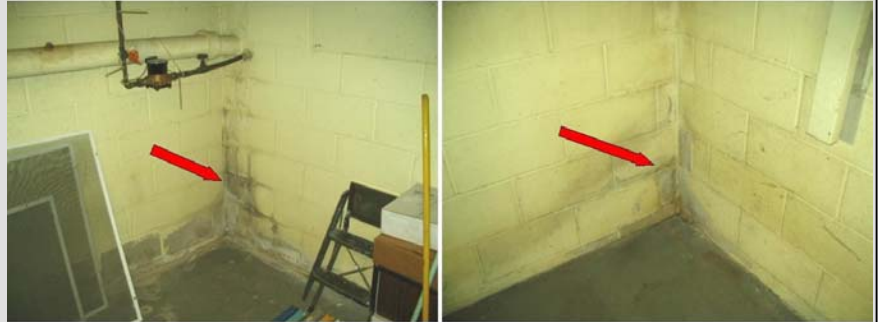
Staining in corners indicates periodic moisture.

Current water penetration was not noted however signs of typical moisture were found. The following type of staining/moisture was observed: Dry stains and stained/discolored areas. Seen at front and rear right corner of foundation. Stains were dry at the time of the inspection. Recommend checking with seller as to history of leaks. Potential for future leakage in any areas of previous staining exists. Recommend sealing walls in the future with a drylok type paint where accessible to help minimize moisture infiltration. Evidence of minor water seepage was observed at the front of the foundation wall. Wood paneling is stained at the floor and has moisture readings from 7-13% at the bottom of the paneling. Recommend having section of paneling removed to make sure no microbial growth (mold) is present at this location. Concrete block foundations are porous and subject to occasional seepage however moisture contact with building materials should be avoided. Further evaluation is recommended to determine where moisture is entering. We can not predict the frequency or amount of future water penetration. There is always the potential for moisture entry during a heavy rainfall with any type of foundation that has areas below grade. It is important to maintain positive grading and pitch away from the foundation.

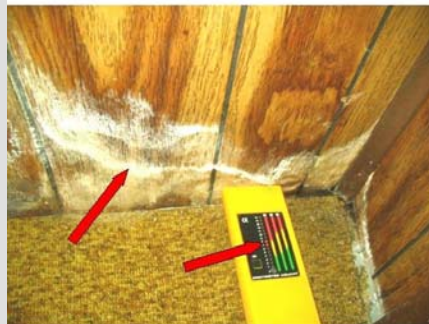
Staining and elevated levels of moisture present on paneling.

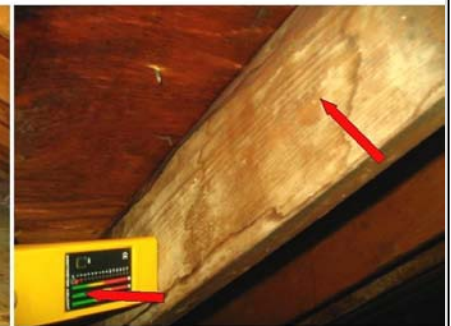
Stains on framing was dry.

Attic is partial, Accessible, No problems were observed at the time of the inspection. Stains observed on wood in attic area indicate previous leakage in a few locations. Stains observed were dry at the time of the inspection. Stains were checked with a moisture meter at the time of the inspection and levels were normal. Wood and insulation was dry in the surrounding area. Recommend checking with sellers if they are aware of previous leakage. The stains may be from prior to having the roof replaced.

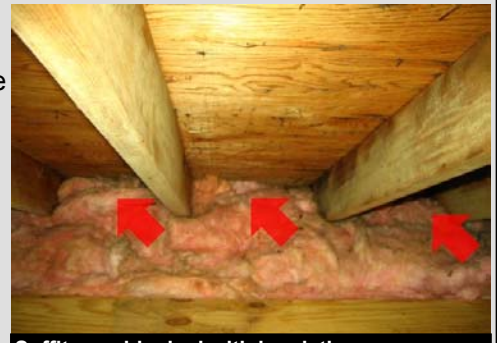
Fiberglass batts, Insulation is installed between ceiling joists, Appears serviceable, A few of the soffit vents are being blocked by insulation that is installed up against the roof. We recommend pulling back the insulation to allow air circulation to take place. Styrofoam inserts call "raft-R-mates" can be purchased at a small cost to keep insulation away from roof sheathing and allow proper air flow.

Soffits are blocked with insulation

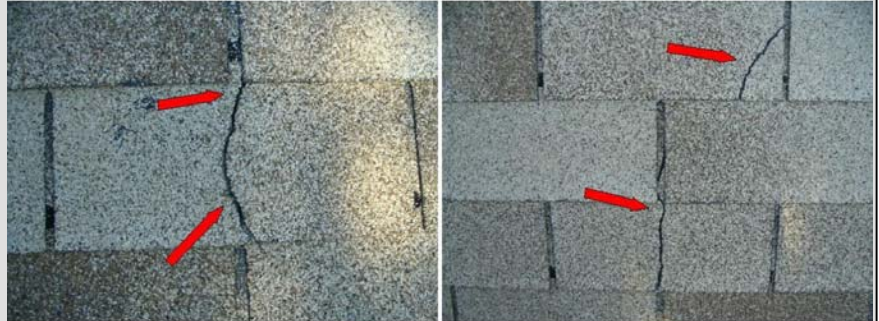
Several shingles are cracked through to felt paper.

Damage/Deterioration/Defects noted. Several of the shingles at the front of the upper roof have cracks present through shingles. This is an indication of older shingles that have sustained excess weathering and aging. No evidence of active leakage was observed from interior locations. Anticipate on the need for replacement of the roof in the near future. Recommend having a licensed roofer further assess the roof to make repairs or replace as needed.

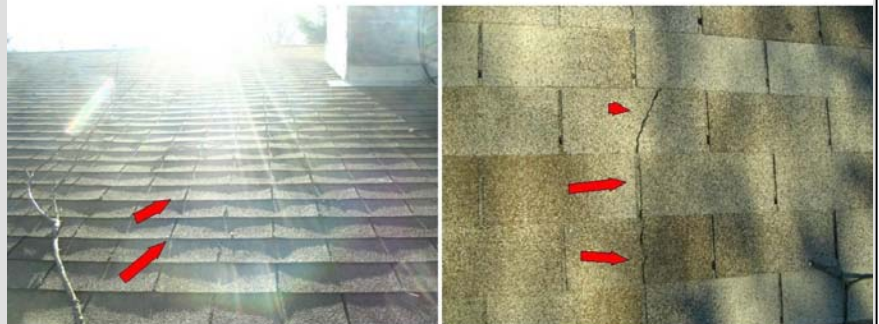
Shingles at rear of house beginning to curl. Cracked shingles at front roof.

building and should be performed on a regular basis. Beginning stages of curling was viewed on the rear lower roof. This is an indication of an older roof that will need replacement within the next few years.

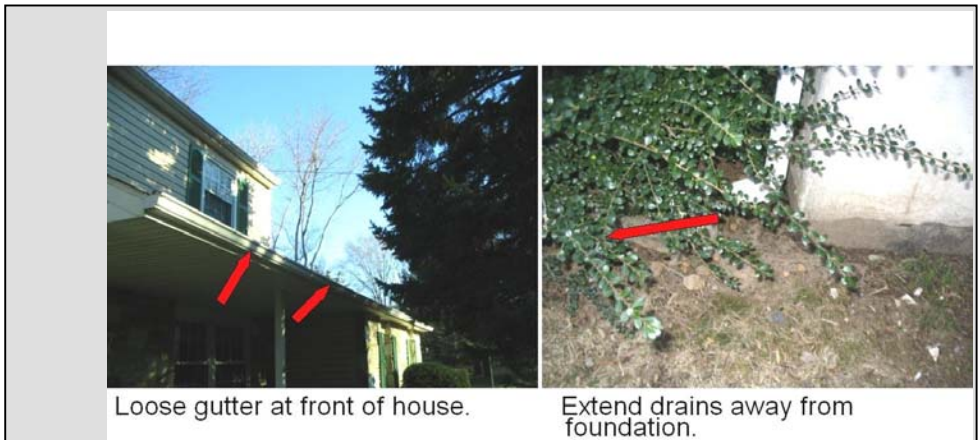
Full, Appears serviceable, Loose gutter is present at front of lower porch roof. Recommend securing these to the structure with appropriate fasteners. Debris in gutter. Gutters should be cleaned regularly to avoid drains from backing up and causing interior water damage. Route downspouts away from the building with proper splash blocks or downspout extensions. The further water is taken away from the foundation, the less the risk of water infiltrating through the foundation.

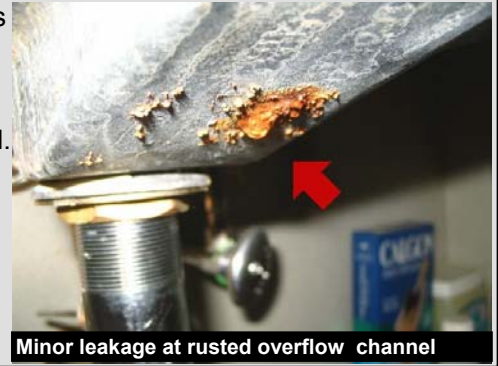
Appears serviceable, Counters/cabinets appear serviceable, The following problems were noted at the sink: Minor leaks are present at overflow channel below sink due to rusting of the channel. Sealant/repair is needed to prevent leakage. Anticipate on the need to replace the sink in the near future due to the rusting. Patching will be only a temporary repair.

Minor leakage at rusted overflow channel

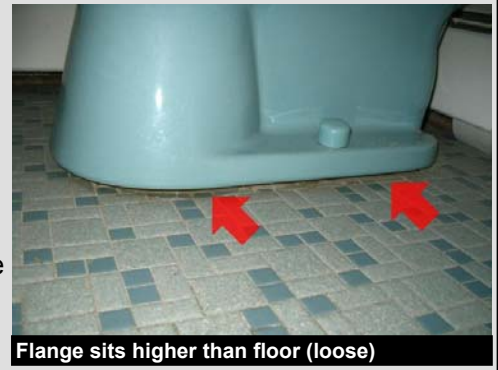
The following problems were noted at the toilet: Toilet is loose due to the flange sitting higher than the floor. Repairs recommended to prevent toilet from moving which can damage the drain pipe. Shimming the toilet will typically prevent movement and should not cost much to repair. Replacing or lowering the toilet flange would be more costly and require the assistance of a licensed plumber. Further evaluation and repairs recommended.

Flange sits higher than floor (loose)

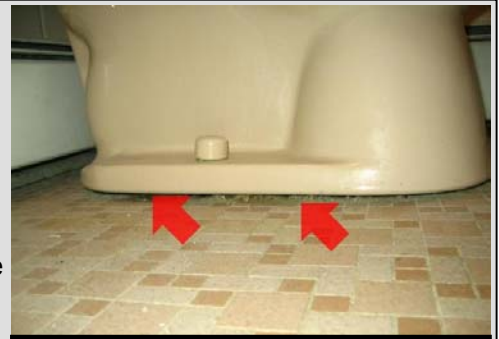
The following problems were noted at the toilet: Toilet is loose due to the flange sitting higher than the floor. Repairs recommended to prevent toilet from moving which can damage the drain pipe. Shimming the toilet will typically prevent movement and should not cost much to repair. Replacing or lowering the toilet flange would be more costly and require the assistance of a licensed plumber. Further evaluation and repairs recommended.

Loose toilet due to raised flange
