Property Inspection Report

XXXXXX Place
XCXXXX, PA 190XX
Prepared for: Mr. & Mrs.XXXXXXX

Prepared by: Insight Home Inspections, Inc.
XXXXXXXXXX
Warminster, PA 18974
215-674-1808

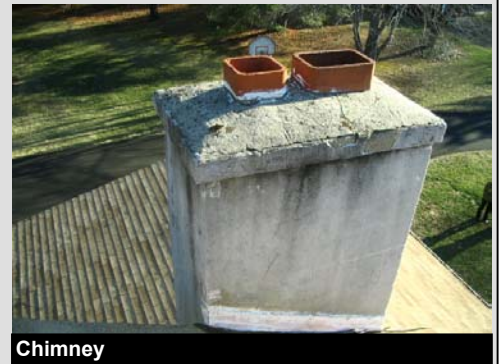
Concrete block with mortar coating.

Appears serviceable. Recommend installing a rain cap in the future to prevent any excess moisture damage to flue liner and possible staining on the inside chimney wall as well as keeping birds and animals out. Keep in mind to maintain the chimney crown, masonry surfaces and flashings. This can be done by applying mortar and stucco to the top of the chimney and sealant around the flashings to keep water from entering cracks and causing damage.

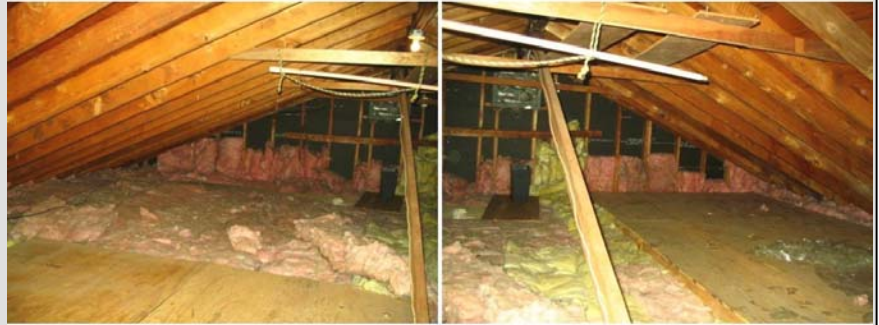
Attic area.

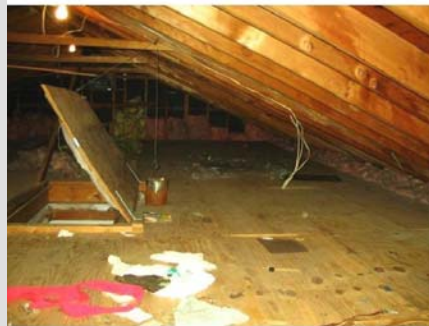
Rear of attic area.

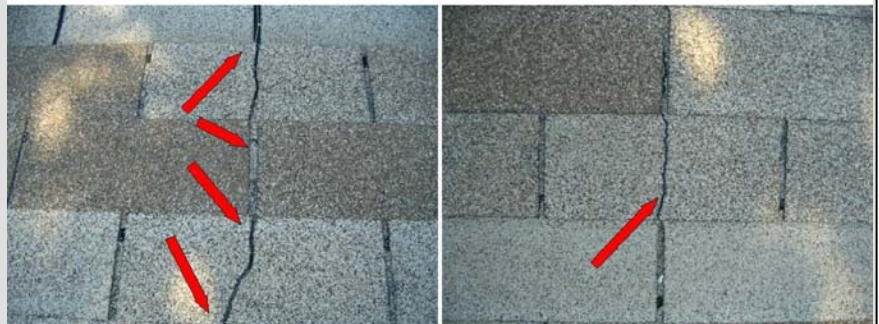
Several shingles are cracked through to felt paper.

Damage/Deterioration/Defects noted. Several of the shingles at the front of the upper roof have cracks present through shingles. This is an indication of older shingles that have sustained excess weathering and aging. No evidence of active leakage was observed from interior locations. Anticipate on the need for replacement of the roof in the near future. Recommend having a licensed roofer further assess the roof to make repairs or replace as needed.
